Actions to improve *Salix alba* and *Populus alba*
galleries (92A0) in two Natura 2000 areas, Greece

Vasiliki Tsiaoussi

THE GOULANDRIS NATURAL HISTORY MUSEUM
GREEK BIOTOPE/WETLAND CENTRE

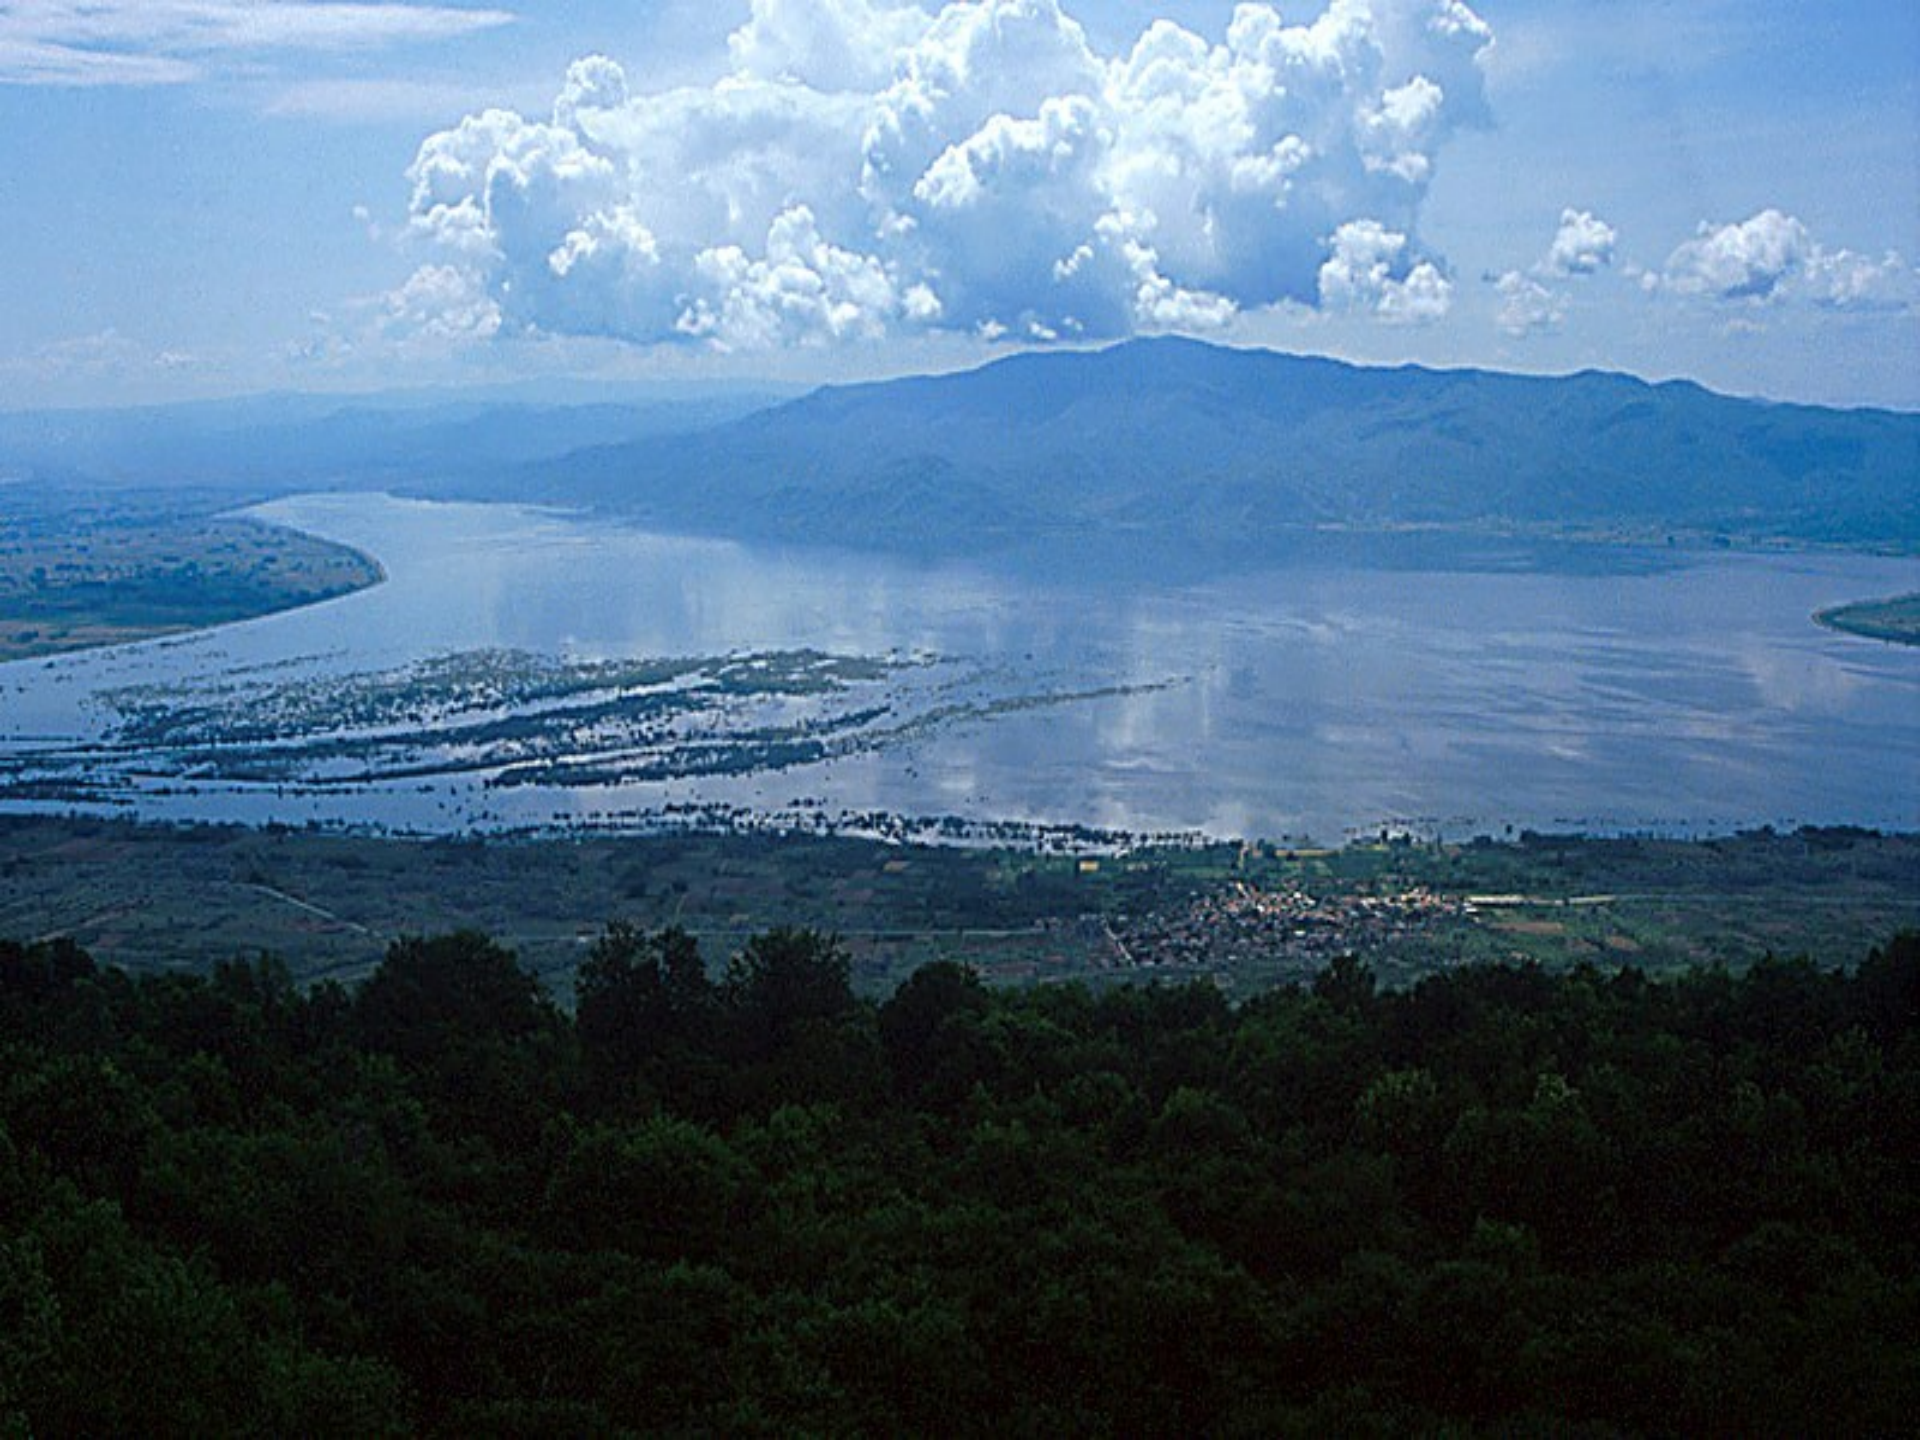
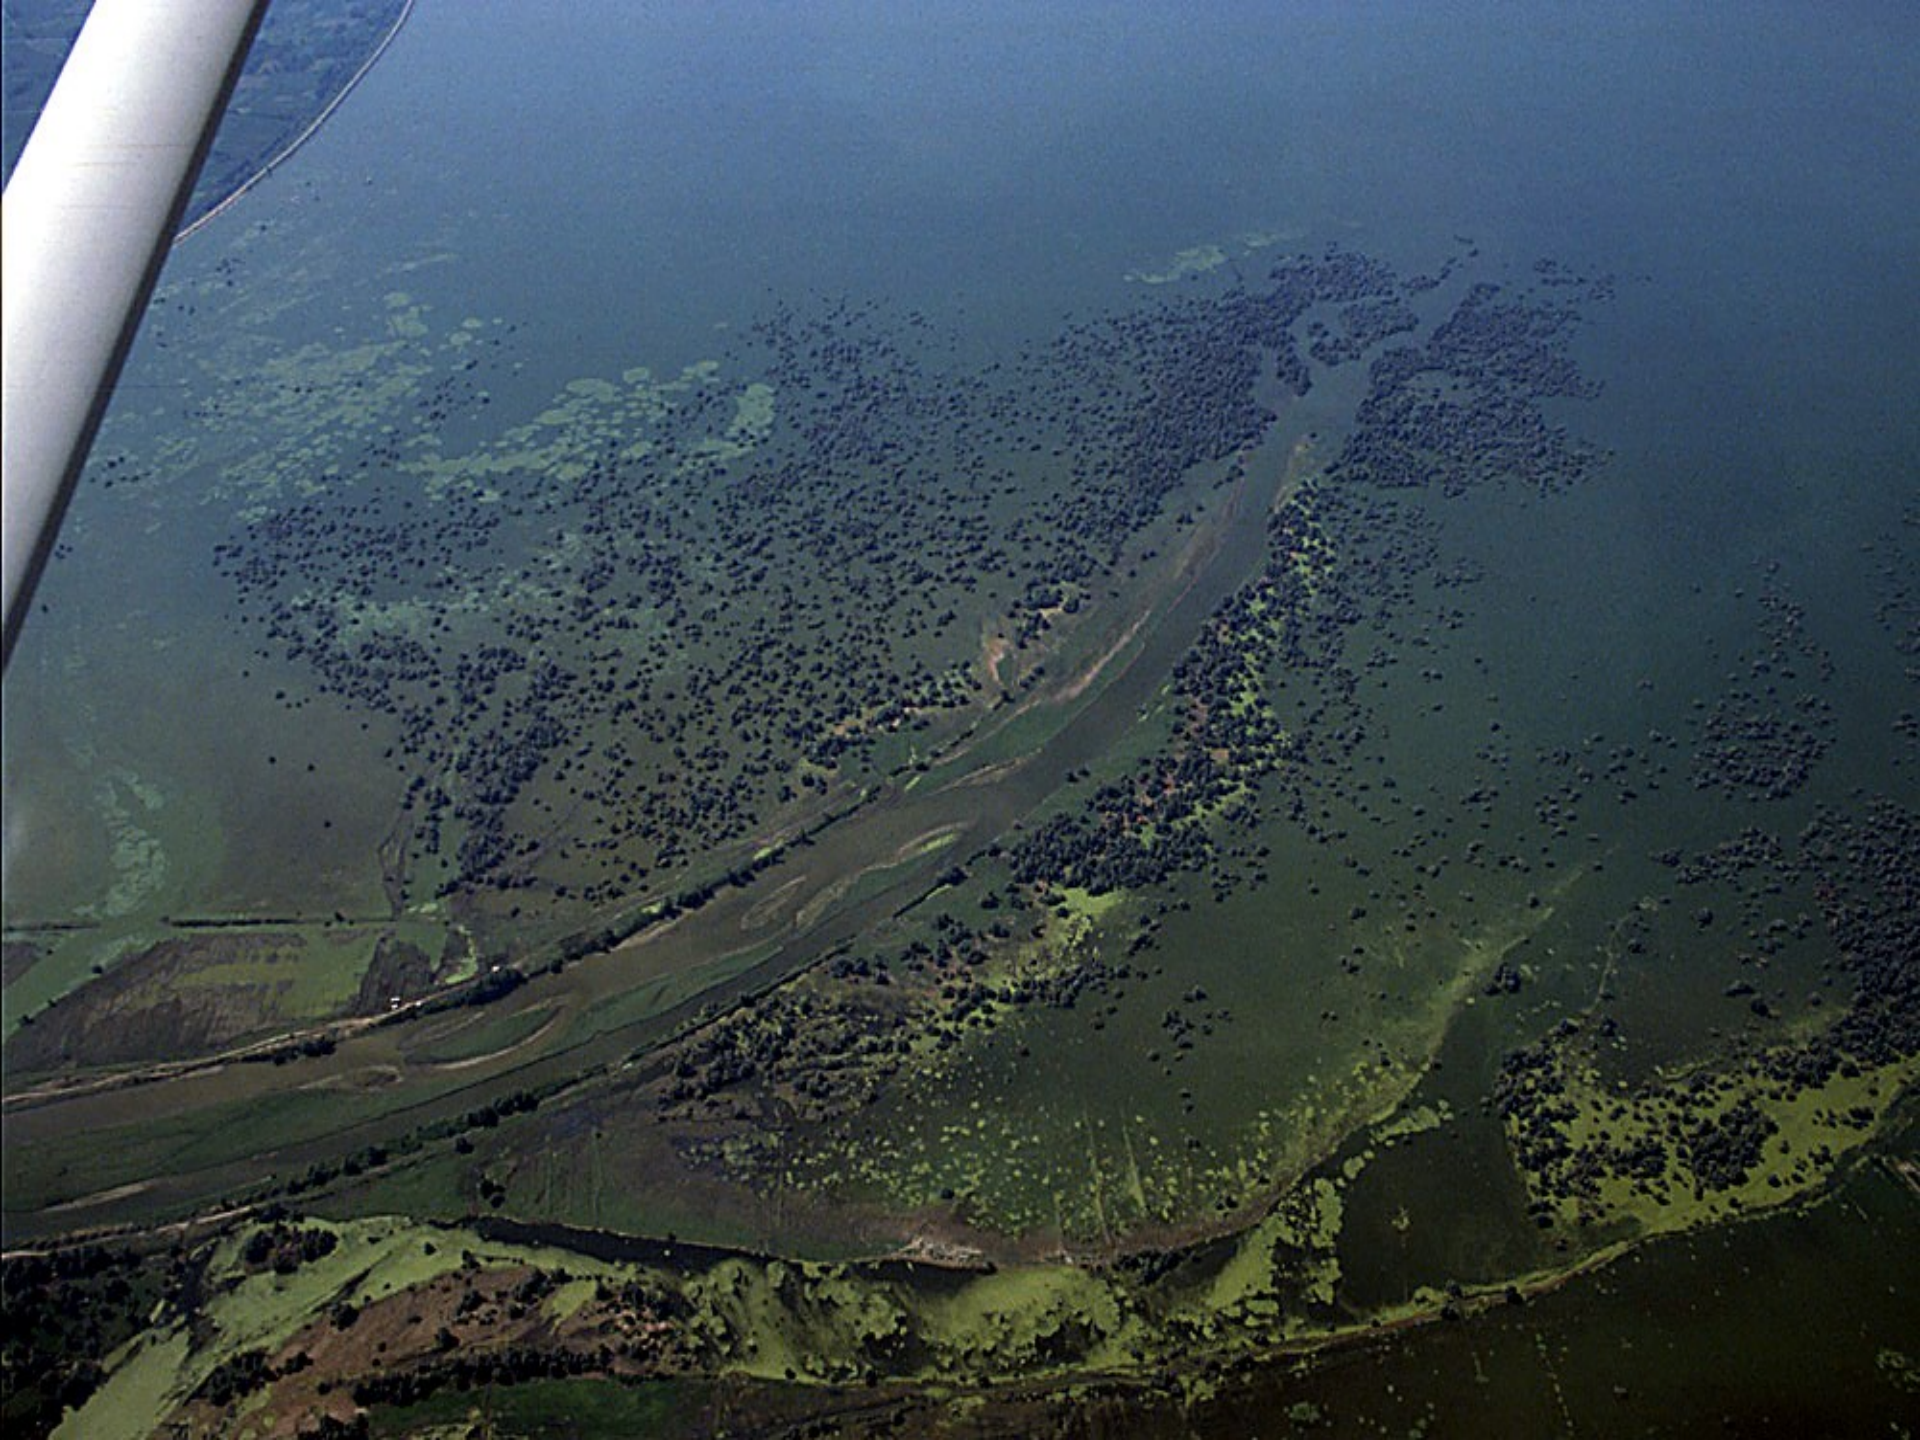
The problem:

Two conflicting sectors: agriculture and nature conservation

Abrupt and extreme raise of water level in spring in the past 30 years

Shrinkage of riparian forest from 670 ha to ~ 200 ha

Degradation of structure – open patches, low regeneration
